**MARYLAND HISTORICAL TRUST  
DETERMINATION OF ELIGIBILITY FORM**

Property Name: William H. Wildesen Farm Inventory Number: G-V-B-035

Assess Visual Effects of Allegheny Heights Windpower

## INVENTORY FORM FOR STATE HISTORIC SITES SURVEY

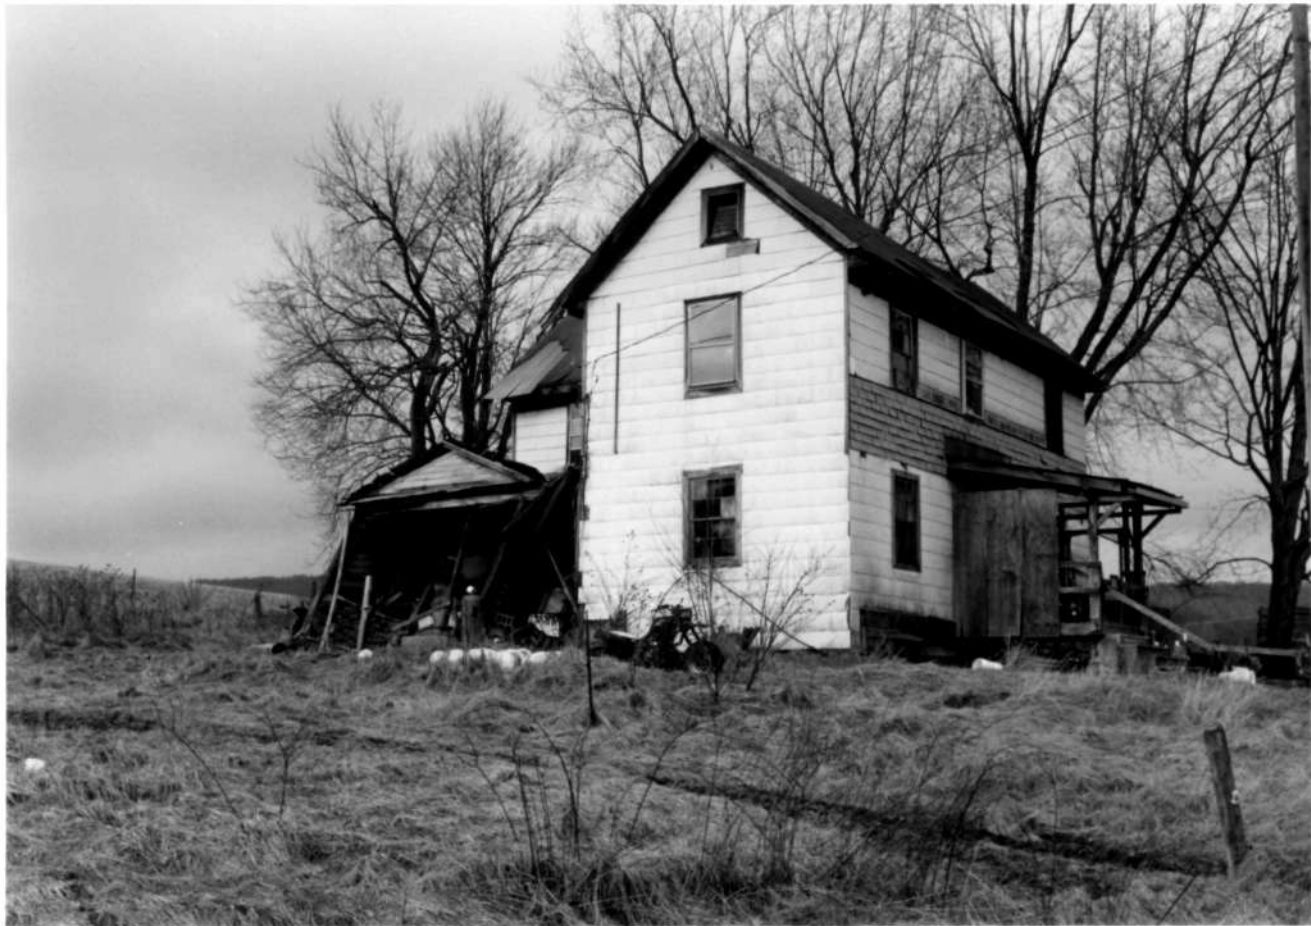
MD 5440

The two-story, three-bay by one-bay house was constructed ca. 1890 and appeared on the USGS Oakland quadrangle map surveyed in 1899 and published in 1908 (USGS 1899, 1908). The house currently is vacant and in disrepair. The wood-frame building is clad with asbestos shingles and has a band of asphalt shingles between the first and second stories on the front elevation. The asymmetrical three bay façade has an off-center doorway. The door is not visible through the glass storm door. A transom is located over the doorway. The windows are six-over-six-light, double-hung sash units set in plain wood casings; many window panes are broken. The side gable roof is sheathed with metal sheets. The eave has a box cornice along the front elevation. The 1981 MIHP form recorded no porch on the building, although the presence of the asphalt shingles between the first and second stories suggested that a one-story porch once spanned the front elevation. Currently, a one-bay porch constructed of scrap

wood shelters the doorway. The ell once had a one-story porch with front-facing gable roof. This porch is barely standing.

DWELLING, VIEW SW

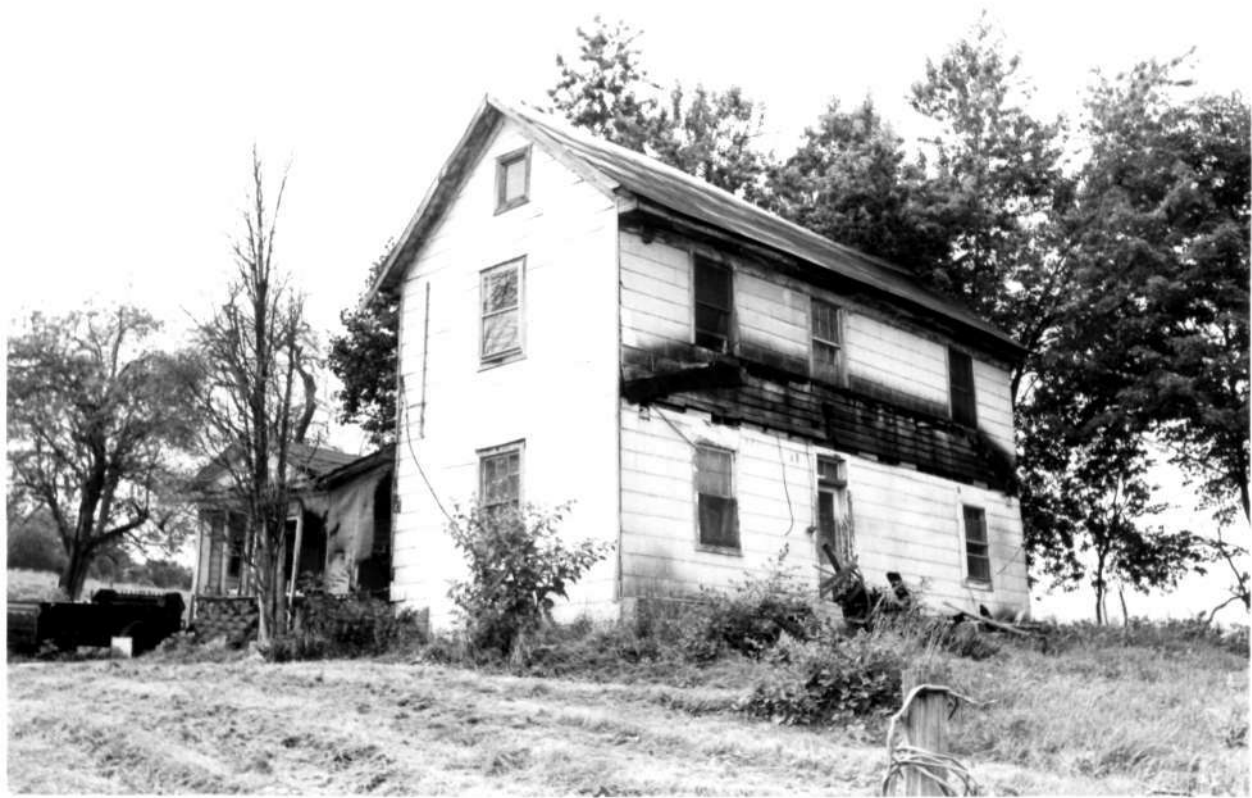
G-V-B-035

This frame house is situated in a hilly area off Oak Grove Road, approximately 3/4 miles northwest of Route 560. The house faces southeast. It is a two story, three bay by one bay gable roof structure with a two bay by one bay ell. A single story enclosed porch addition with a gable end front roof is located facing off from the southwest elevation of the ell. The roof of this enclosed porch however appears to be about to cave in. It is evident from the marks on the facade that it once had a porch also. The house can be entered from the rear porch and from the central front entrance with transom.

An interior brick chimney is located on the southwest elevation of the ell where it meets the main block. Six over six windows light the house except for the rear southwest and northwest elevations where two over two sash windows have been installed. The house rests on a stone foundation. The original German siding exterior has been covered with asbestos shingles.

Facade: SE & SW elevations

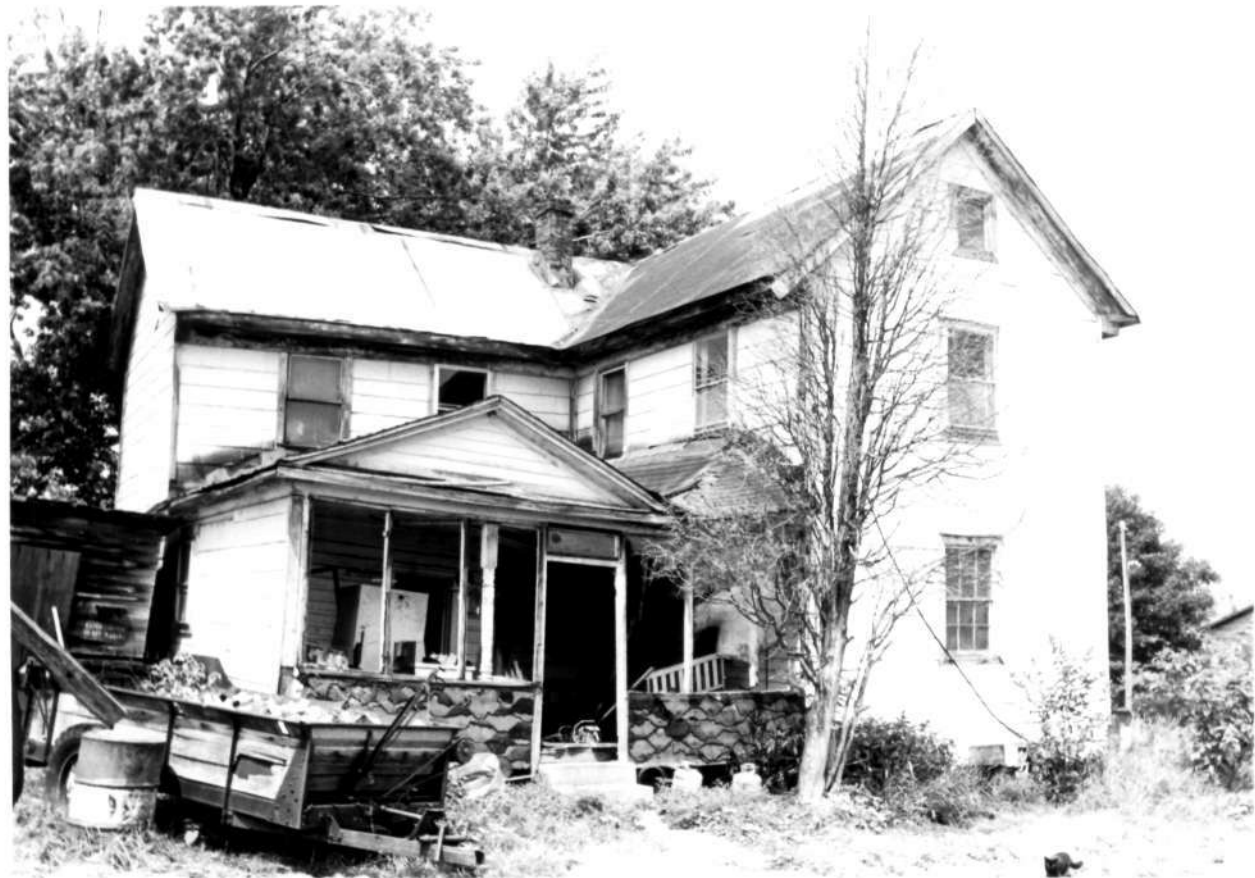
G-V-B-035

Rear: SW elevation
